**FINAL  
PHASE II (a) FIELD SAMPLING PLAN FOR  
TRENCHES, PITS, EXCAVATIONS, BUNKERS, FORMER  
BUILDINGS, AND GROUND SCARS**

**OF THE  
CAMP EDWARDS IMPACT AREA  
GROUNDWATER QUALITY STUDY**

**MASSACHUSETTS MILITARY RESERVATION  
CAPE COD, MASSACHUSETTS**

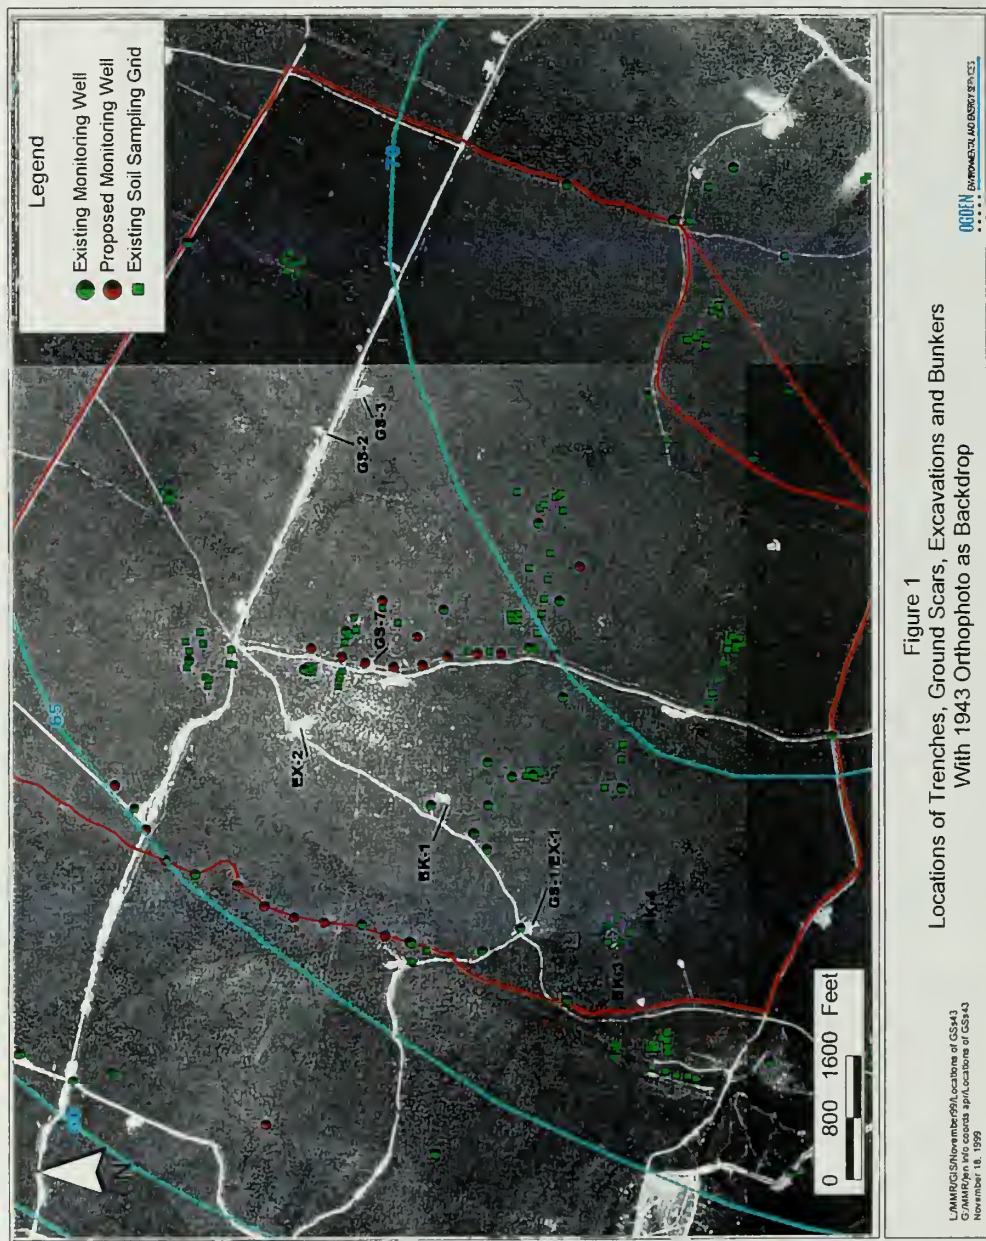
Figure 1. Locations of Trenches, Ground Scars, Excavations, and Bunkers with 1943 photo.

The locations of features described in this plan are illustrated in Figures 1-3. These three maps show the extent of features over one or more years, using aerial photos from 1943, 1955, and 1966. The existing wells and existing soil sampling grids on these maps are from the IAGS Phase I investigations. The proposed monitoring wells on these maps are the locations proposed in the RDX Response Plan (Ogden, 1999d).

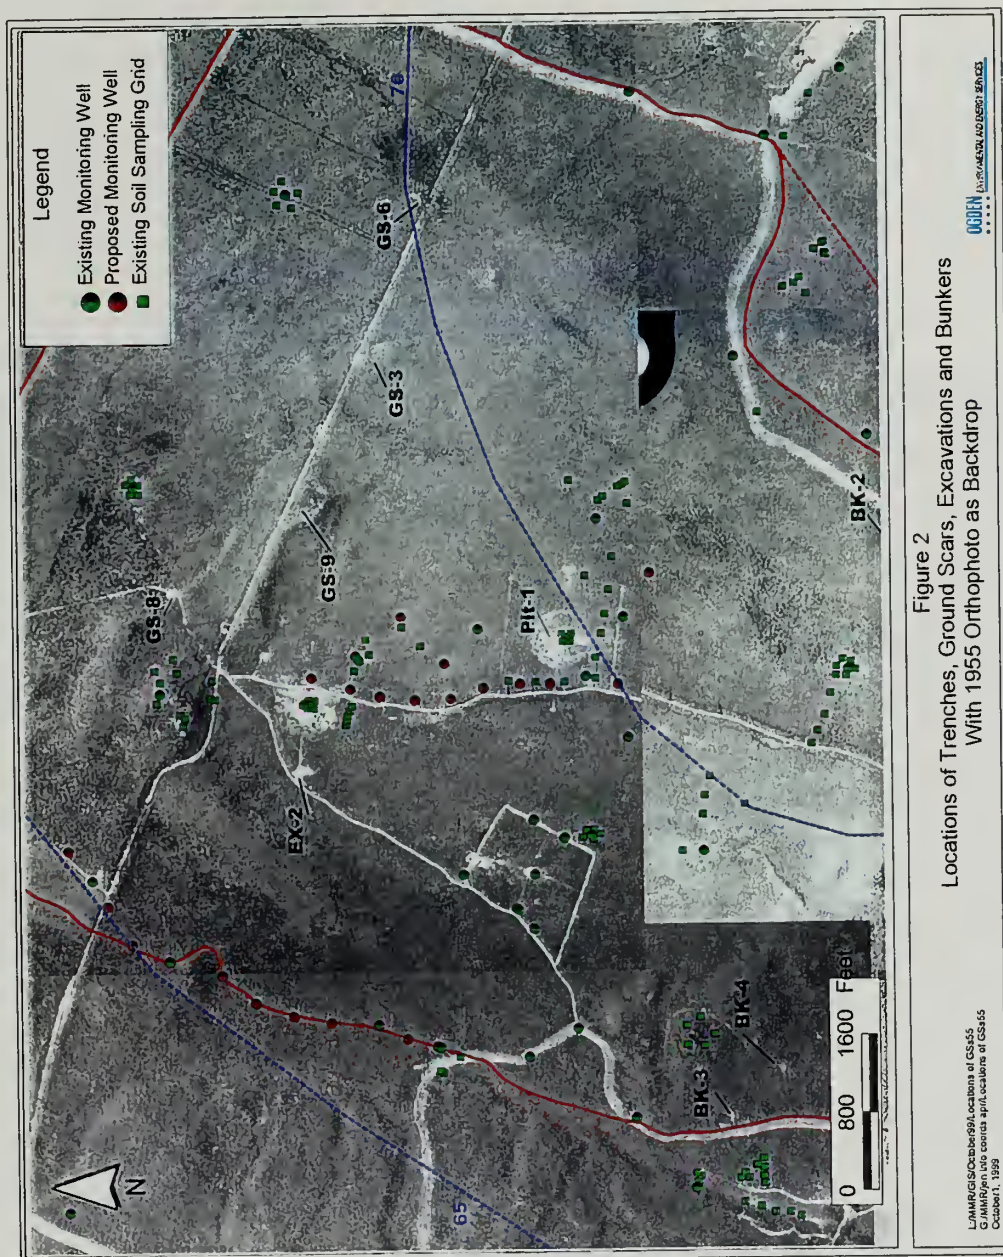
Figure 2. Locations of Trenches, Ground Scars, Excavations, and Bunkers with 1955 photo

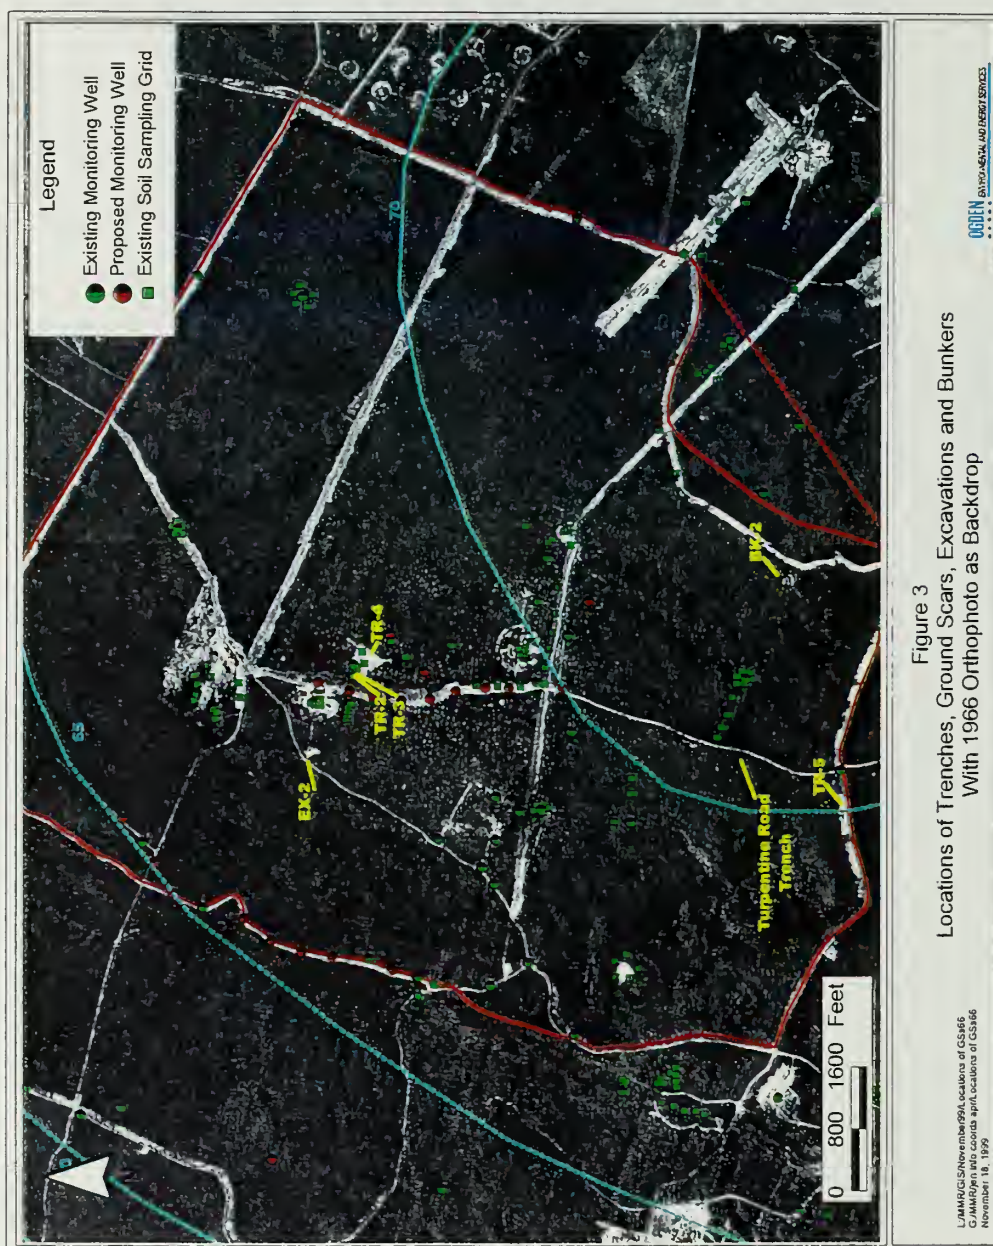
Figure 3. Locations of Trenches, Ground Scars, Excavations, and Bunkers with 1966 photo

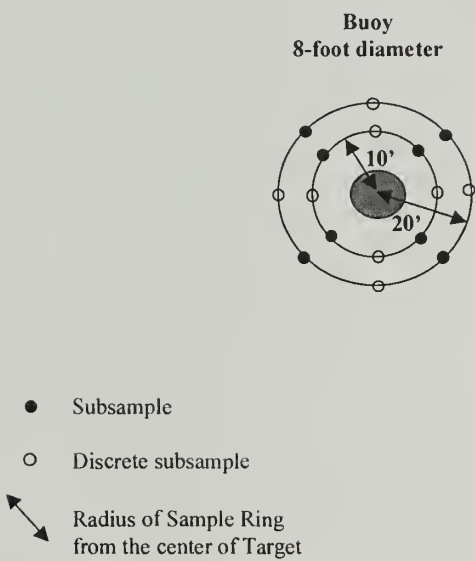
**Figure 4**  
**Soil Sampling Arrangement at Target Buoy (GS-7)**

Ground Scar 7 is proposed for investigation based on the buoy target, craters, and munitions present at this location. Soil sampling will be conducted beginning in the area immediately surrounding the target. Contaminant concentrations are expected to be highest in this area. Samples will be arranged in concentric rings around the target, so that contaminant concentrations at varying distances can be determined. If contaminants are detected at the furthest distance sampled, additional sampling will be proposed for the target. The sampling arrangement is indicated in Figure 4.

Two rings of samples will be placed around the target at GS-7, at radii of 10 feet and 20 feet from the center of the buoy. Each ring will have 8 evenly distributed subsamples separately homogenized and four points where discrete samples are taken, split into two subsamples, one used for the ring composite and the other analyzed as a discrete sample. The sampling arrangement is indicated in Figure 4. Each of the subsamples in a ring will be composited to provide one concentration of possible contaminants in soil of equal distance from the target. The discrete samples will be located where the north, south, east and west axes of the target intersect the rings. Sampling depths are 0-6 and 18-24 inches bgs.

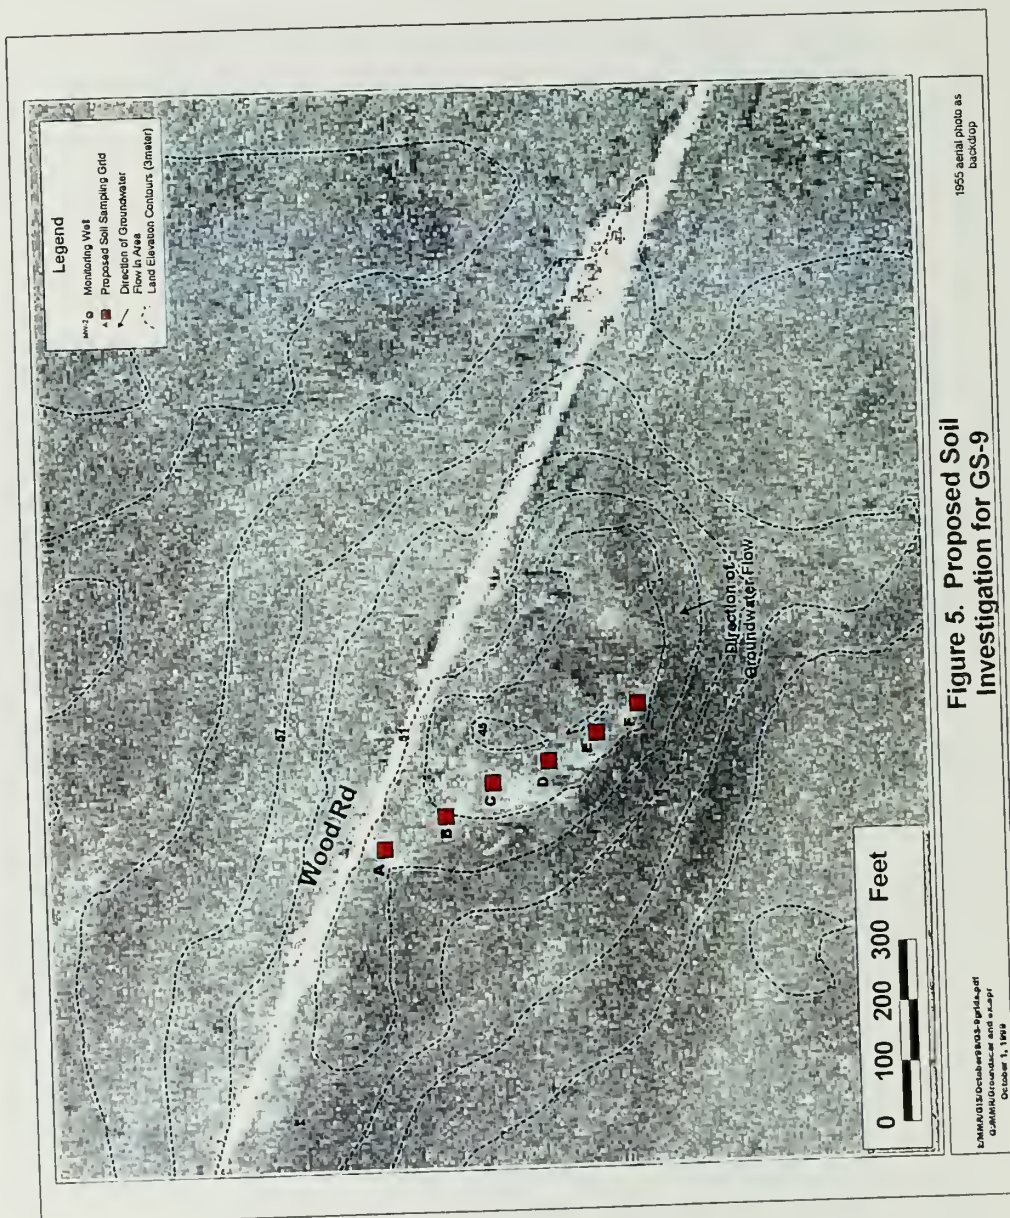
Figure 5. Proposed Soil Investigation for GS-9

The topographic depression and its western hillside in the location of the former scar will be investigated due to the craters observed here. The proposed focal area for this feature is the western hillside that is lighter colored in the aerial photo, suggesting the greatest ground disturbance. The approximate dimensions of this focal area are 500 feet by 100 feet, or 1.1 acres. Using a sampling density of five grids per acre as was done for Phase I of the IAGS, six soil sampling grids are proposed for this area, as indicated in Figure 5. The sampling grids will be relocated in the field to include any areas of cratering or thinner vegetation.

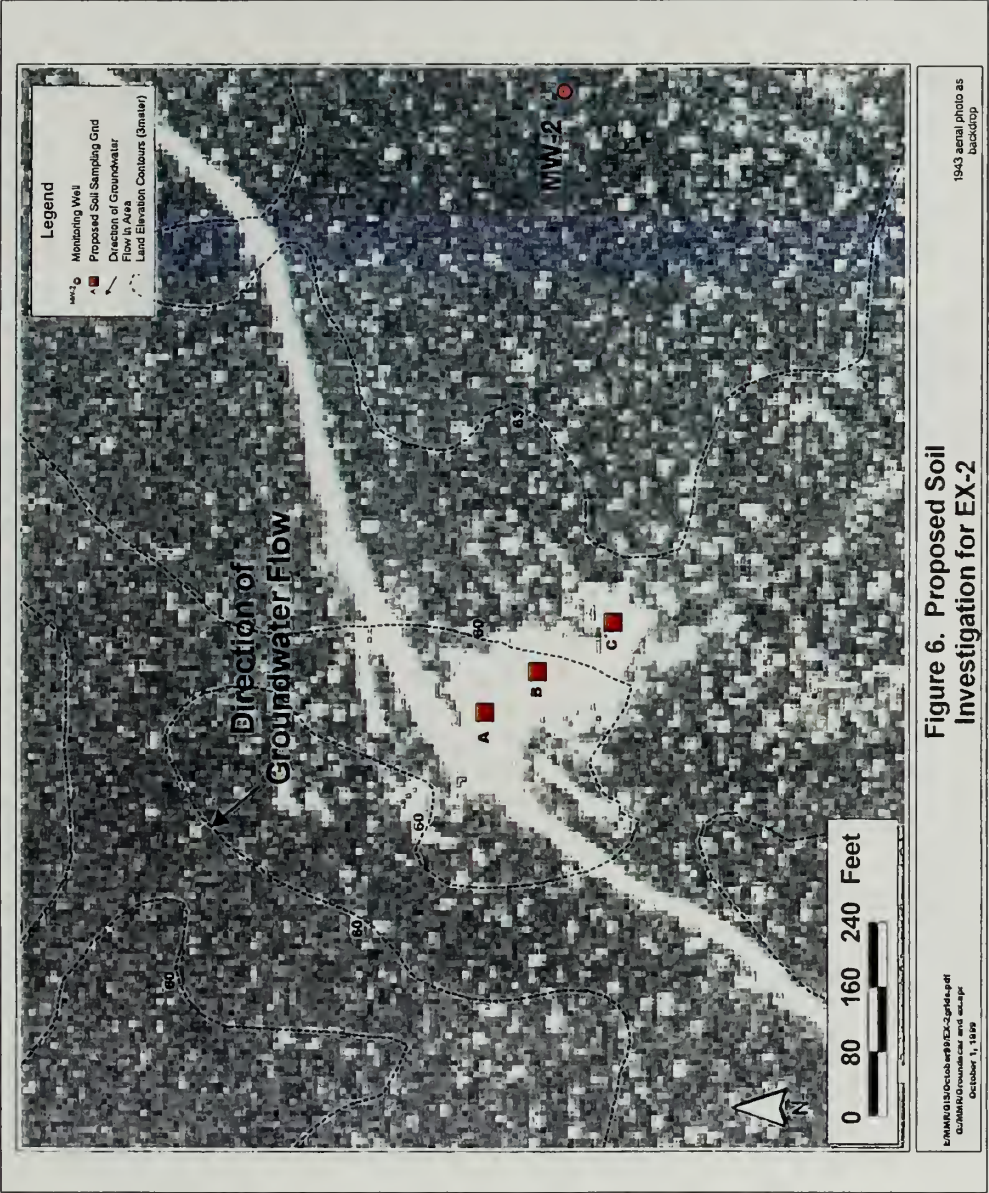
Figure 6. Proposed Soil Investigation for EX-2

Excavation 2 is proposed for investigation based on the craters and training rounds present in this area. The proposed focal area for this feature is the extent of cleared area in the 1943 aerial photo, which is the largest of the areas for the years between 1943 and 1966. The approximate dimensions of this focal area are 200 feet by 130 feet, or 0.6 acres. Using a sampling density of five grids per acre as was done for Phase I of the IAGS, three soil sampling grids are proposed for this area, as indicated in Figure 6. The sampling grids will be relocated in the field to include any areas of cratering or thinner vegetation.

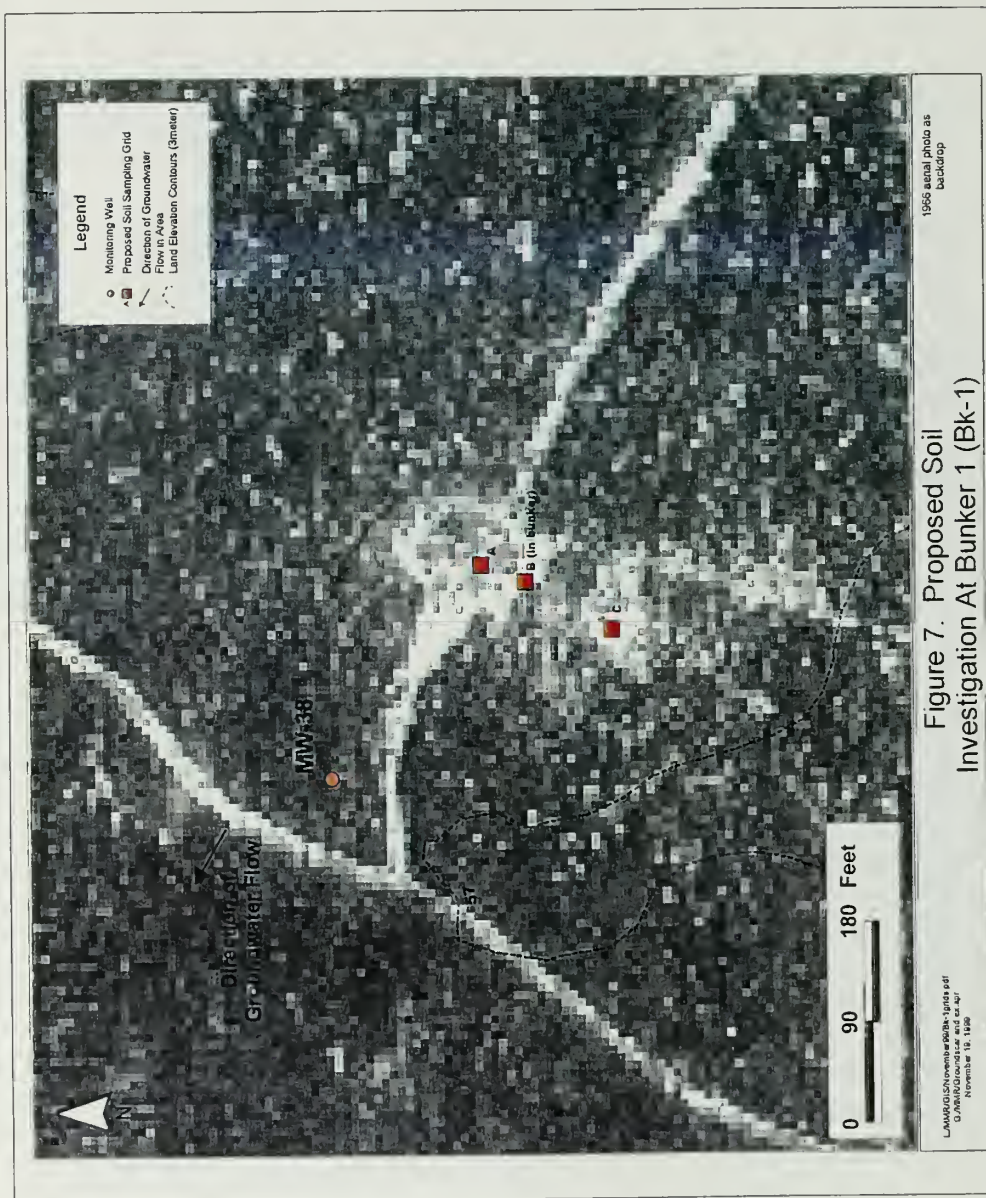
Figure 7. Proposed Soil Investigation at BK-1.

Bunker 1 and the cleared area south of it are proposed for investigation based on the activities that occurred in CS-19. The approximate dimensions of the cleared area are 85 feet by 85 feet, or 0.2 acres. Using a sampling density of five grids per acre as was done for Phase I, one soil sampling grid is proposed for this area. The sampling grid will be relocated in the field to include any areas of thinner vegetation. A sampling grid will also be located above/behind (north of) the bunker, where munitions and other debris are visible. A composite soil sample will also be collected from the dirt floor of the bunker. This will be a composite of at least three locations on the floor, designed to be representative of the total area of dirt. Each subsample will be collected from 0-3 inches, unless a barrier (flooring material) is present in which case the sample will not be advanced below the barrier. Sampling locations are indicated in Figure 7.

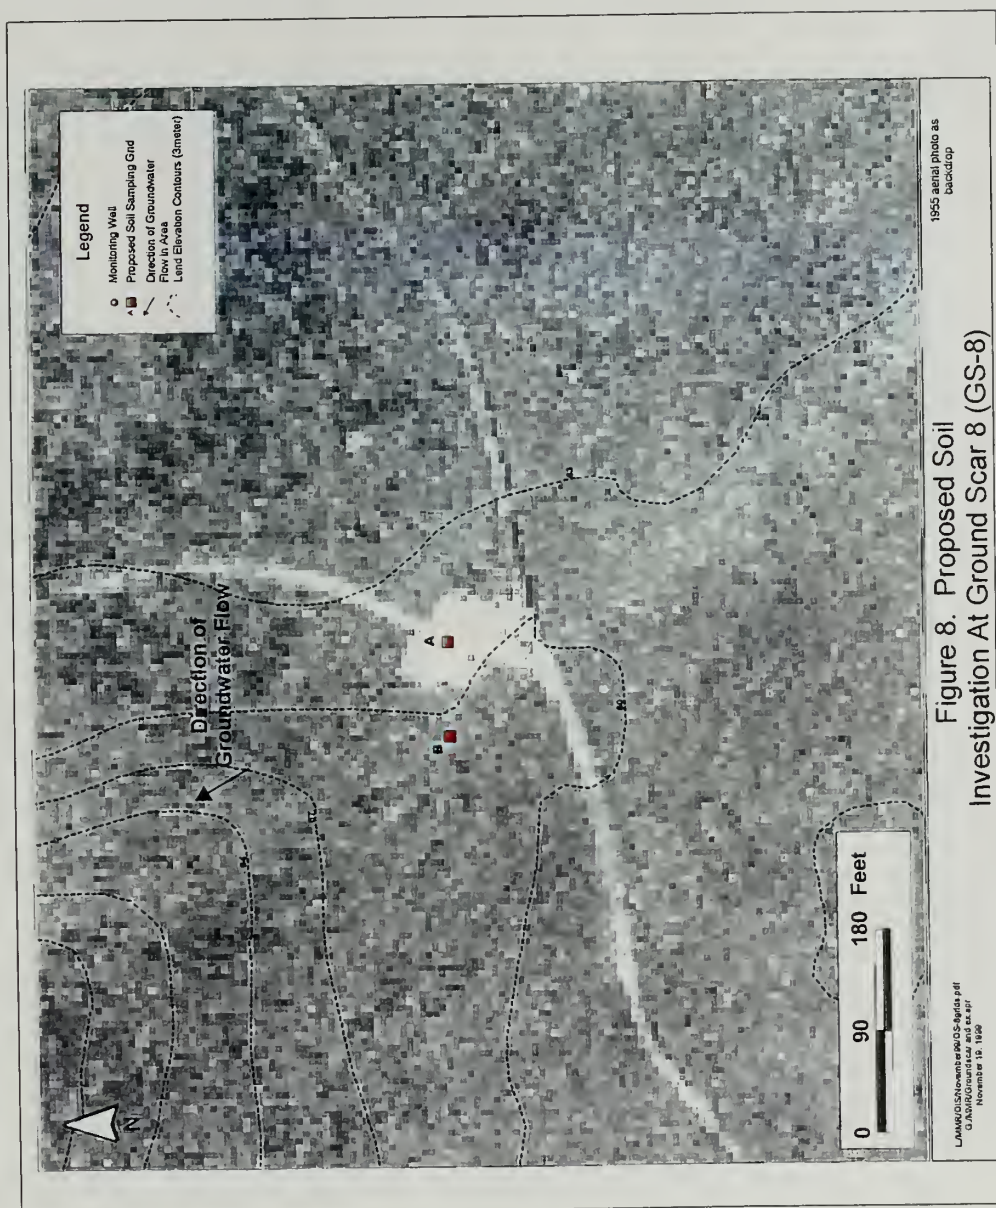
Figure 8. Proposed Soil Investigation at GS-8.

Ground Scar 8 is proposed for investigation based on historical aerial photographs and some scrap metal surficial material observed at this location. Two sampling grids will be located in this area, as indicated in Figure 8. One grid will be located within the GS-8 clearing, which measures approximately 50 by 100 feet in the 1955 and 1963 aerial photos. A second grid will be established surrounding the debris observed in the reconnaissance, unless the first grid covers this area in which case the second grid will be located about 100 feet west of the first grid.

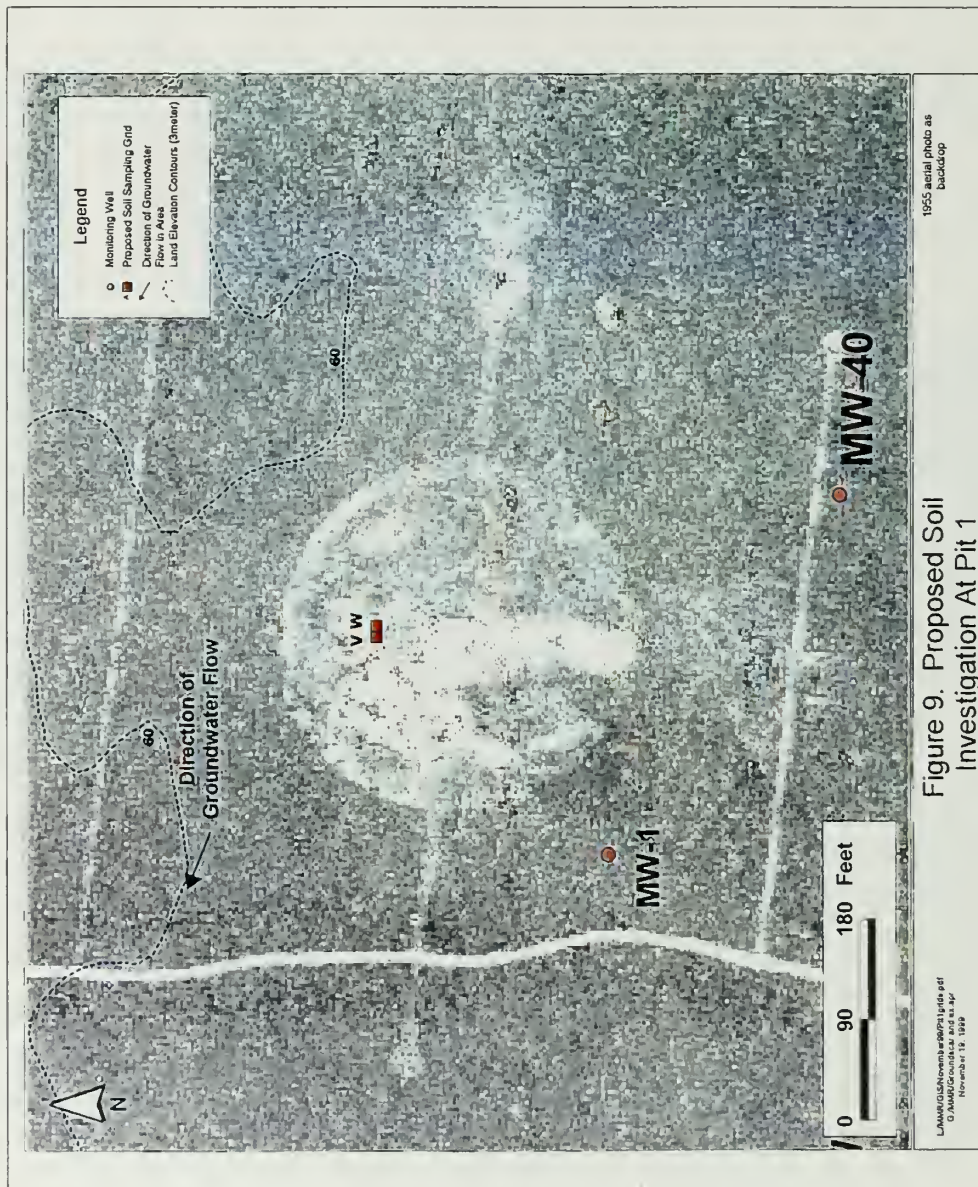
Figure 9. Proposed Soil Investigation at Pit 1.

former circular cleared area at the location identified as a “possible pit” based on aerial photo analysis. No pit was observed in this area during the August 1999 reconnaissance. The Guard will conduct additional reconnaissance of this area by helicopter in December 1999. If no pit is observed from the airborne reconnaissance, the two grids will be placed adjacent to each other at the location indicated by the photograph. Grid locations are illustrated in Figure 9.

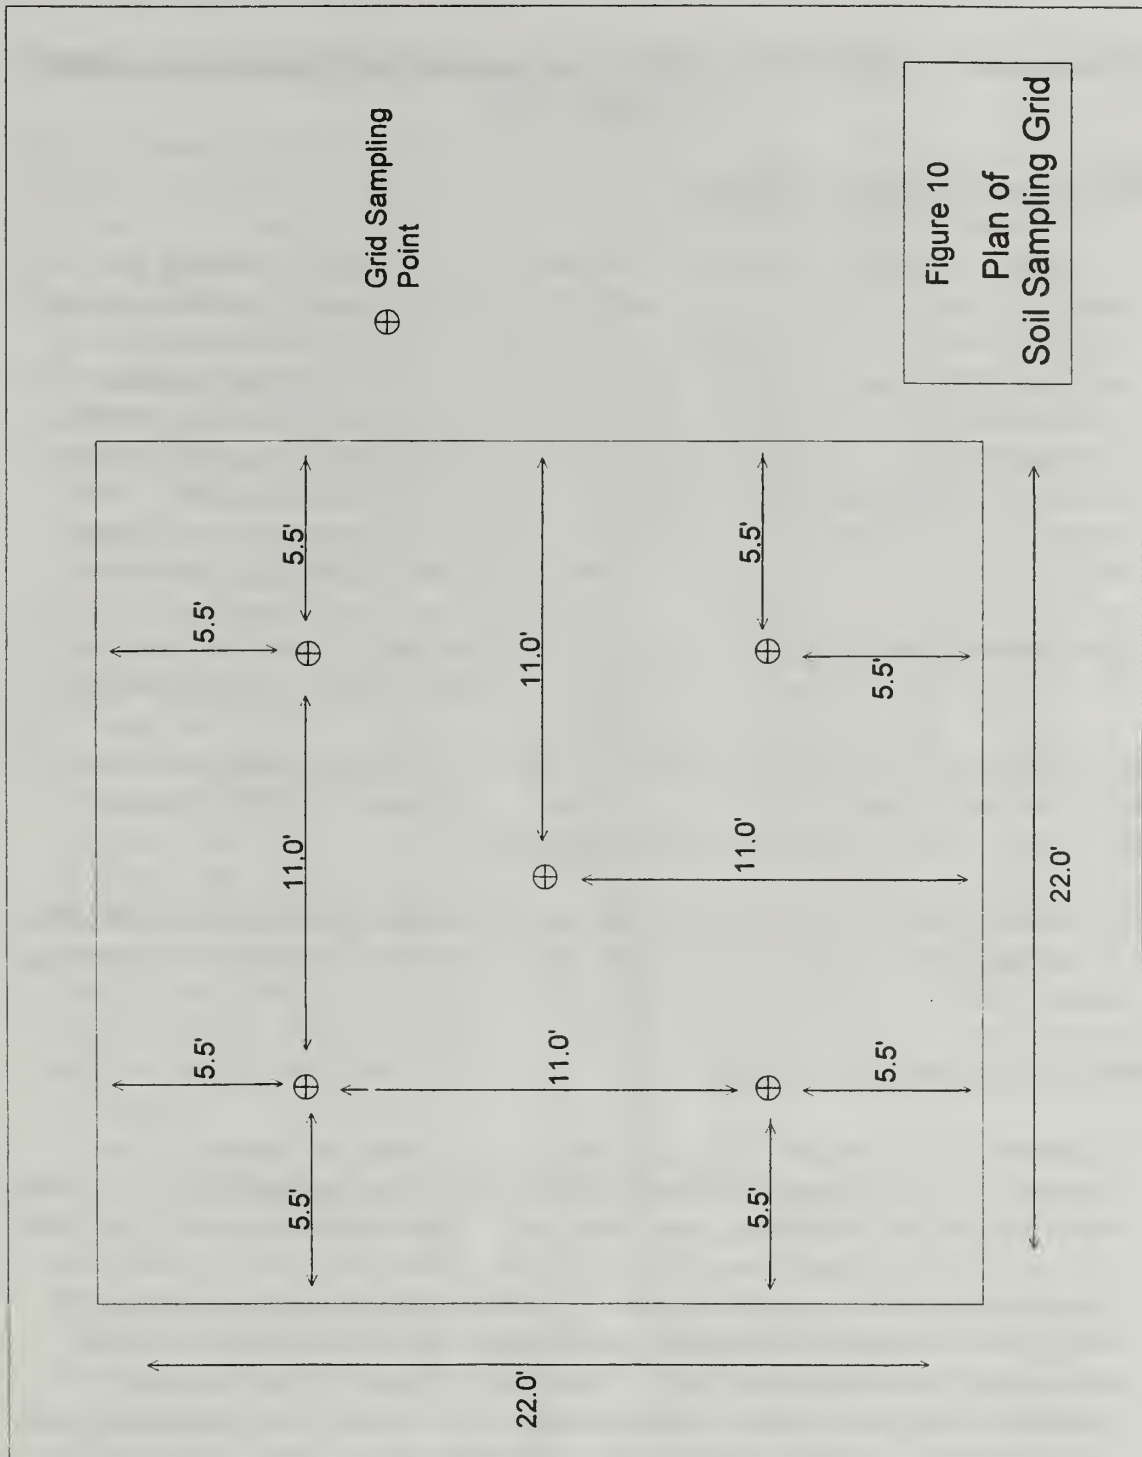
Figure 10  
Plan of  
Soil Sampling Grid

Soil sampling grids measuring 22 x 22 feet will be used for sampling GS-8, GS-9, Pit-1, EX-2, and BK-1. Individual subsampling points for the five-point grids are illustrated in Figure 10. Each five-point grid will have all five subsamples separately homogenized

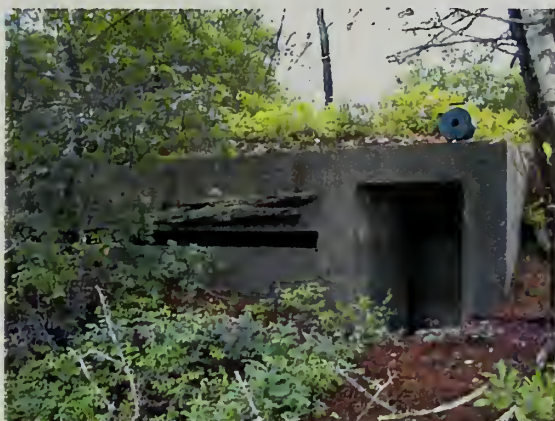
Photo 1: Bunker 2

BK-2 (photo 1): This bunker is located off of Wheelock Road in a fairly flat area. The bunker appears to have been built and then covered with soil and vegetation. The concrete bunker has a dirt floor. The bunker faces the north. No targets are visible from the bunker. There is no evidence of waste disposal or stressed vegetation in or outside the bunker. There are no signs of detonation in the area. There is no debris in the area.

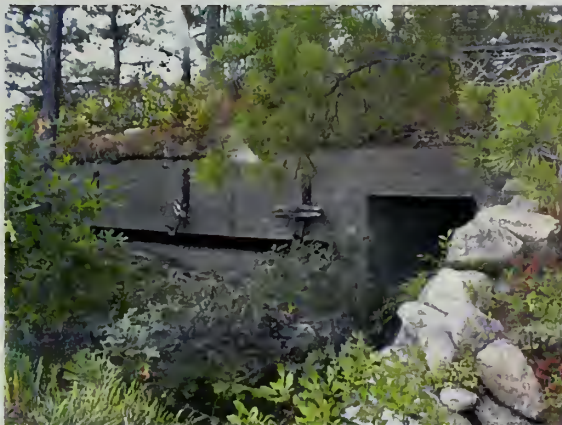
Photo 2: Bunker 3

BK-3 (photo 2): Bunker 3 is built into the side of an existing, east facing slope. It was most likely used to view mortar targets located across the Succonsette Pond kettle hole. There is no evidence of waste disposal or stressed vegetation in or outside the area of the bunker. The area is very heavily vegetated.

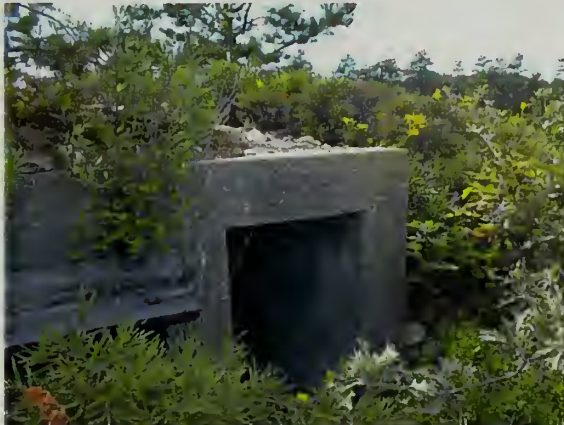
Photo 3: Bunker 4

BK-4 (photo 3): Bunker 4 also faces mortar targets located east of Succonsette Pond. It is located southeast of Bunker 3, deep in the brush. The dirt floor and concrete walls do not look damaged in any way. There is no evidence of waste disposal or stressed vegetation in or outside the bunker. The former road to the bunker is heavily vegetated and mostly unrecognizable.

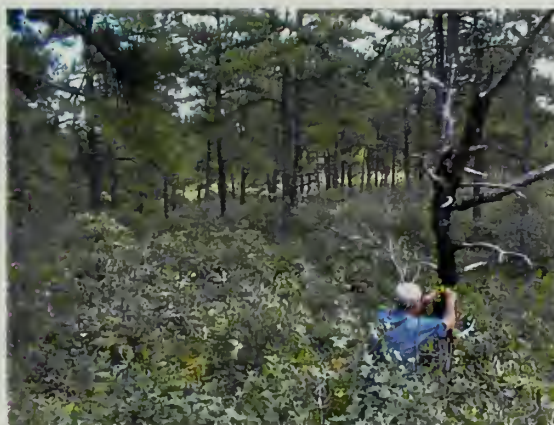
Photo 4: GS-2

GS - 2 (Photo 4): This ground scar visible in the 1943 air photo was located on the north side of Wood Road and east of Five Corners. The area is completely revegetated with trees and brush. Black ash-like stains are present on some of the trees in the area but a

specific burn area was not recognizable.

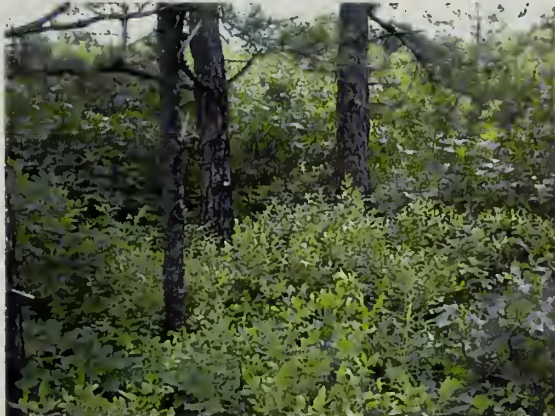
Photo 5: GS-3

GS – 3 (Photo 5): This ground scar visible in the 1943 and 1955 air photos was located on the south side of Wood Road, east of GS-2. The broad, shallow topographic depression where the scar was located is completely revegetated with brush. There are no current signs of scarring or damage to vegetation in the area.

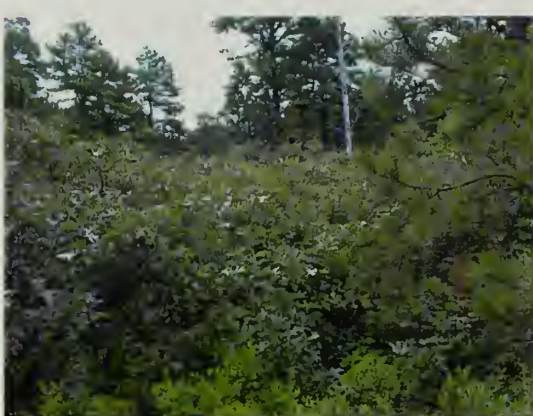
Photo 6: GS-4

GS – 4 (Photo 6): This ground scar visible in the 1943 air photo was located on the north side of Wood Road, east of GS-3. Black ash-like stains are present on some of the older trees in the area. The area is completely revegetated with brush, and currently there is no visible sign of scarring.

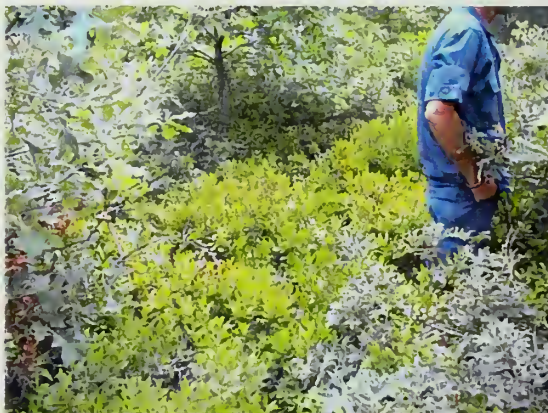
Photo 7: GS-5

GS – 5 (Photo 7): This ground scar visible in the 1943 air photo was located on the north side of Wood Road, east of GS-4. There is no current sign of scarring to the ground. Black ash-like stains are present on some of the older trees in the area. The area is completely covered with thick brush and trees.

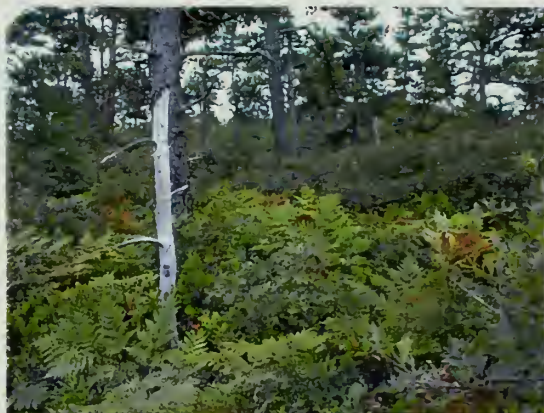
Photo 8: GS-6

GS – 6 (Photo 8): This ground scar visible in the 1943 and 1955 air photos was located on the north side of Wood Road, east of GS-5. The area where the scar was located is a broad, shallow topographic depression that is completely covered with vegetation. There are no signs of impact or other damage to the ground.

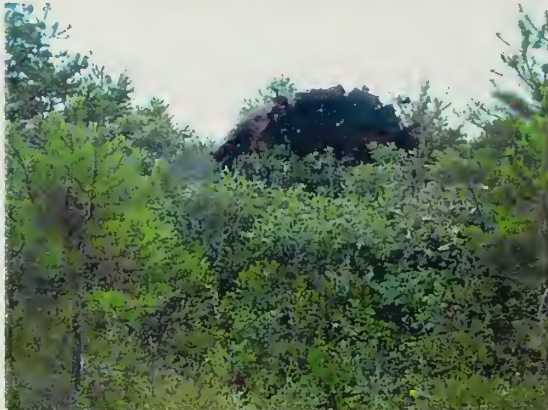
Photo 9: GS-7

GS – 7 (Photo 9): GS-7 was a ground scar visible on the east side of Turpentine Road in the 1943 air photo, south of Five Corners. There is a buoy target present here with many impact craters and training rounds surrounding it. The craters lack vegetation. The entire area has thin vegetation cover relative to the surrounding area.

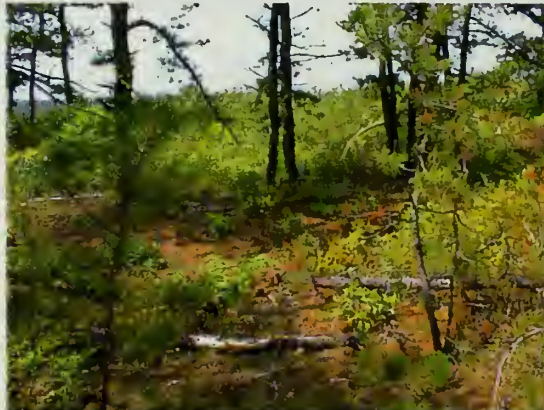
Photo 10: GS-8

GS – 8 (Photo 10): This ground scar was located along the west side of Pocasset-Sandwich Road north of Five Corners, in the 1955 air photo. This location is also at the intersection of a former road leading northwest from Pocasset-Sandwich Road, and connecting with Goat Pasture Road. The vegetation in the flat area appears thinner than in the surrounding area. An old metal pipe was visible here. No other debris was observed.

1. Page 4, GS-8 (Photo 10) – EPA requests that this former ground scar location be sampled, based on historical aerial photographs and some scrap metal surficial material observed at this location. Although GS-8 is a small cleared area in the 1955 aerials, it is part of a much larger cleared area in the 1966 aerials. EPA requests a minimum of two (2) grids be established in this location.

*The suggested investigations will be added. One grid will be located within the GS-8 clearing, which measures approximately 50 by 100 feet in the 1955 and 1963 aerial photos. A second grid will be established surrounding the debris observed in the reconnaissance, unless the first grid covers this area in which case the second grid will be located about 100 feet west of the first. Both grids are within the apparent clearing in the 1966 aerial photo, otherwise known as GS-11 and characterized as Area 1 in Phase I of the IAGS.*

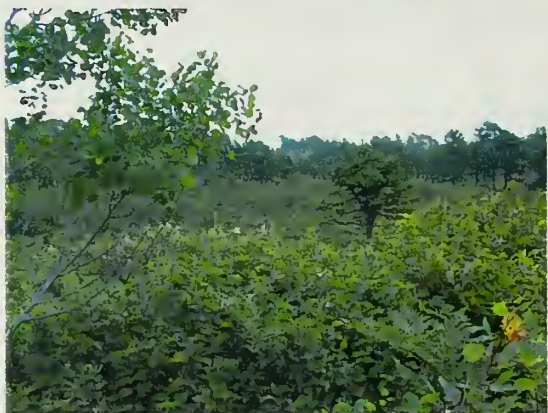
Photo 11: GS-9

GS – 9 (Photo 11): GS-9 was located along the south side of Wood Road east of Five Corners in the 1955 air photo. The former scar area is located in the base of a shallow topographic depression. The base of the depression and the western hillside contain

impact craters, some up to 5 feet in diameter. No training rounds were observed. The area is heavily vegetated with trees and brush, including the craters.

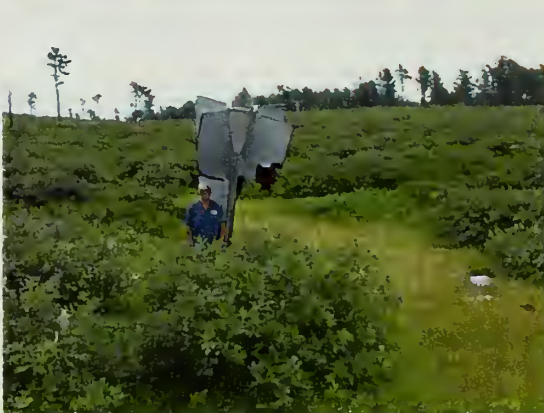
Photo 12: GS-10

GS – 10 (Photo 12): GS-10 was located north of Wheelock road as seen in the 1955 air photo. The location of this apparent former scar is a large topographic depression. There is a target dart in the base of this depression. The area is densely vegetated with the exception of the base of the valley where a few small depressions that may be craters are visible. Impact craters were identified by ERI in the 1958 air photo. No training rounds were observed in the area. Soil sampling is proposed for the area surrounding the target dart, in accordance with the Final Workplan for Phase IIa Activities (Ogden, 1999a).

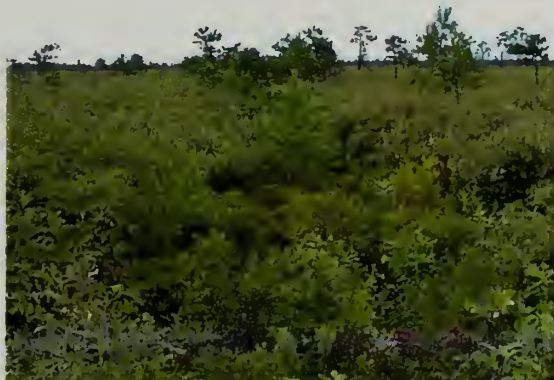
Photo 13: Pit-1

Pit – 1 (Photo 13): There is not one specific pit recognizable in the area identified by ERI in the 1951 air photo. Figure 2 shows the same area in the 1955 air photo. ERI used the notation "possible" to indicate that the feature had only a few of the typical characteristics that allow a pit to be identified by aerial photos. Currently this is a relatively low area, which is heavily cratered and littered with training rounds. The bases of the craters tend to lack vegetation. The area immediately south of the location identified by ERI was characterized in Phase I of the IAGS, as part of "Area 3".

Pit 1 will be investigated based on historical aerial photographs and the current heavily cratered and training-round littered topography. Two grids will be located within the

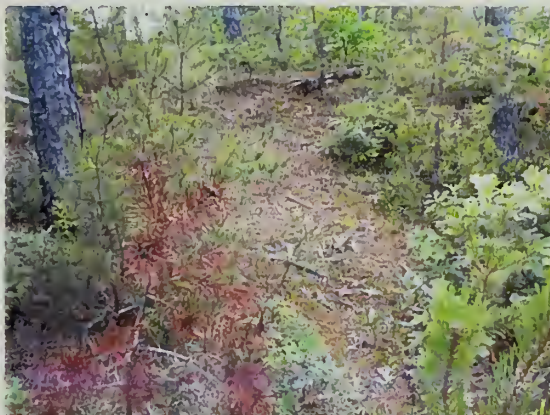
Photo 14: EX-1/GS-1

EX – 1/ GS – 1 (Photo 14): The ground scar/excavation identified by ERI in the 1943 air photo was located on the south side of the intersection of Monument Beach and Pocasset Sandwich Roads. The area now contains trees and some slight brush. No specific excavation was observed. There are possible impact craters in the area but no training rounds were observed. Water table monitoring well MW-9S was installed at this location during Phase I of the IAGS.

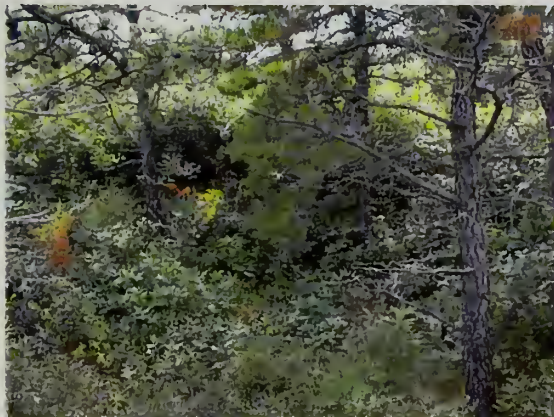
Photo 15: EX-2

EX – 2 (Photo 15): The area of the excavation identified by ERI in the 1951 air photo is now overgrown with scrub pine. Ground disturbance is visible on the 1943, 1955, and 1966 air photos (Figures 1-3). This feature was located on the east side of Pocasset-Sandwich Road, south of Five Corners. No specific excavation was observed. The area is heavily cratered and littered with training rounds. The bottom of the craters lack vegetation.

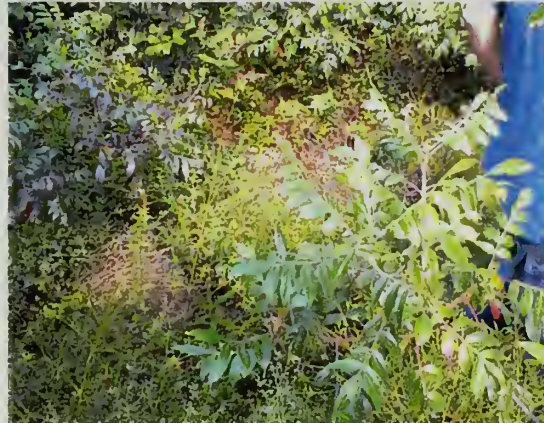
Photo 16: TR-2/3

TR – 2 and 3 (Photo 16): These two trenches identified by ERI in the 1963 aerial photo were located on the east side of Turpentine Road south of Five Corners. The locations are indicated in Figure 3 on the 1966 air photo. This location was investigated as part of “Area 2” in Phase I of the IAGS. The brush in this area is extremely thick and impassable. Two distinct trenches could not be distinguished but the entire area was cratered and pitted. There were many training rounds present in the area.

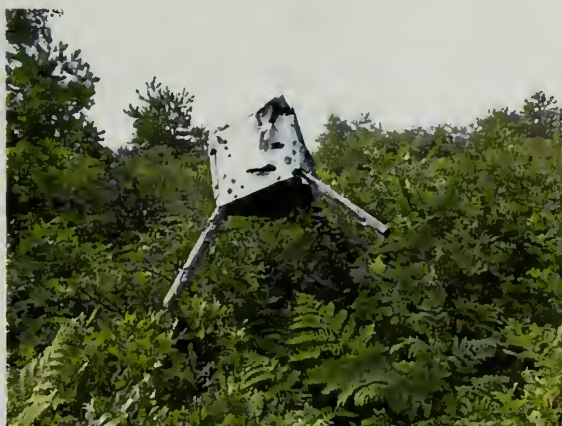
Photo 17: TR-4

TR – 4 (Photo 17): This trench identified by ERI in the 1963 photo was located east of TR-2 and –3, and is also part of “Area 2” in the Phase I investigation. The locations are indicated in Figure 3 on the 1966 air photo. One specific trench is currently not distinguishable. However, in the same location, there is a broad area with many craters and distinct lack of brush. There is a tow-target present here. There are also many training rounds in the area.

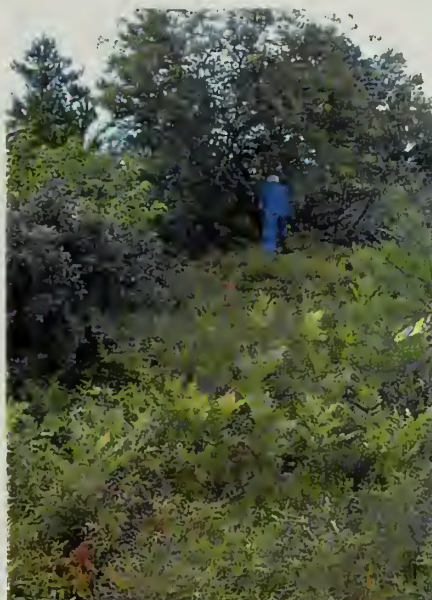
Photo 18: TR-5

TR – 5 (Photo 18): This trench identified by ERI in the 1963 air photo was located along the north side of Wheelock Road west of Turpentine Road, but is not visible now. The area is completely revegetated. Possible tank tracks were observed at this location but they were overgrown with brush and trees.

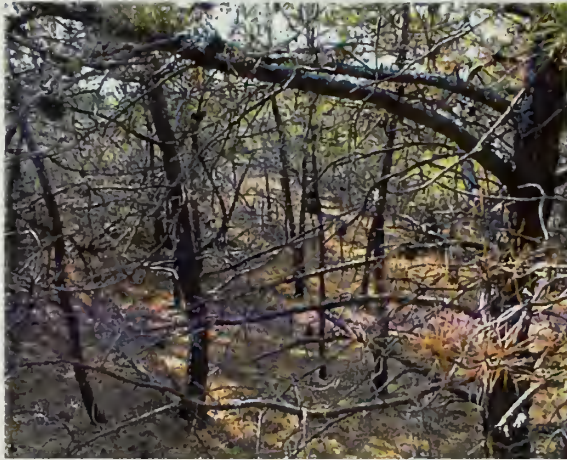
Photo 19: CS-19 Former Cleared Area

BK-1 (CS-19 Bunker, photo 20): This bunker is located approximately 600 feet north of the CS-19 access road and faces north. The access road to this bunker is still clear of heavy vegetation. The dirt floor and concrete walls show little damage. The door and portions of the walls around the door were blown off exposing rebar. The area above and behind the bunker is littered with illumination canisters, mortar fins, and metal debris. The area around the bunker has impact craters, pits, burn marks, and a distinct lack of vegetation. Historic photographs show a cleared area to the south of the bunker. This

cleared area is now overgrown with vegetation (photo 19) but the vegetation type is different from the surrounding area.
